Manhole Inspection Summary

Manhole # S03II2025MH

Location Address: **2903 FALLSTAFF RD**

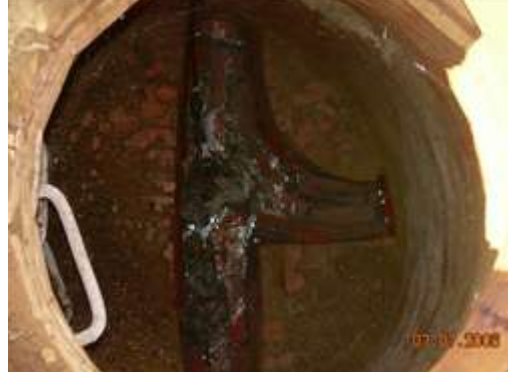
Top View

Infiltration: ☐ None ☒ **Joint** ☐ Cracks ☒ **Mortar** ☐ Roots ☐ Wall

Infiltration: ☐ None ☐ Joint ☐ Cracks ☒ **Mortar** ☐ Roots ☒ **Wall**

☒ **Evidence Of Surcharge** Depth: **1** (ft.) ☐ Active Surcharge Present

Adjustment, Corbel, and Barrel infiltration.
Evidence of surcharge - Bench debris.
Channel debris.

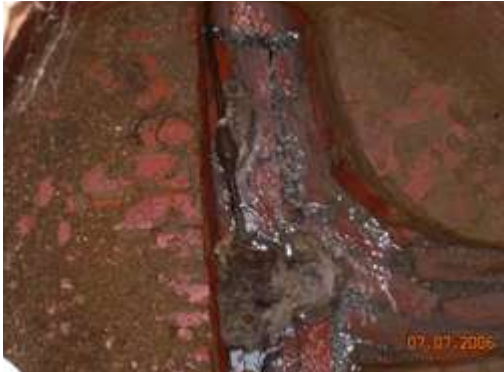
Defect

Comments **The I6 pipe picture shows Channel deterioration.**

Condition: ☐ Sound ☐ Cracked ☐ Root Intrusion ☒ **Deteriorated** ☐ Leaks ☐ Debris

Evidence of surcharge - Bench debris.
Channel debris. Channel deterioration.

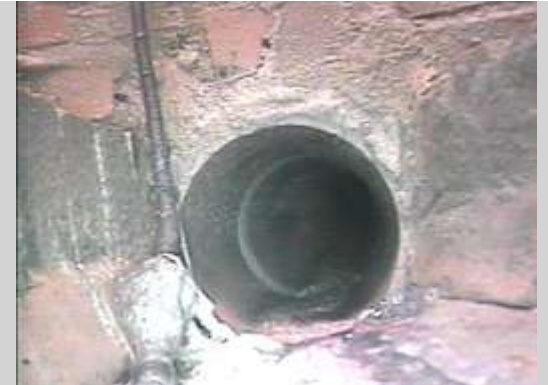
8 in. Circular Gravity Sewer Pipe Out @ 12 O'Clock

Pipe Material: **Clay** ☐ Pipe Lined

Invert Depth: **8.03** (ft.) Flow Characteristics: **Slow**

Infiltration: **None** Pipe Seal Cond: **Unknown**

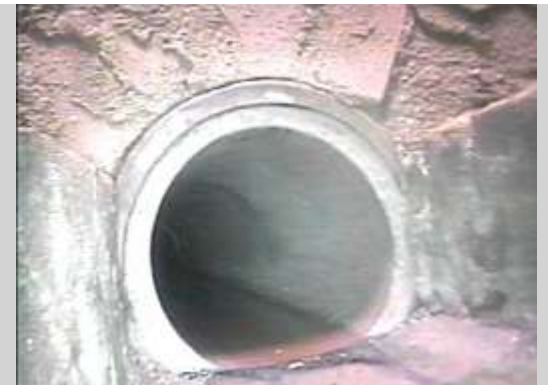
6 in. Circular Gravity Sewer Pipe In @ 3 O'Clock

Pipe Material: **Clay** ☐ Pipe Lined

Invert Depth: **7.75** (ft.) Flow Characteristics: **Slow**

Infiltration: **None** Pipe Seal Cond: **Unknown**

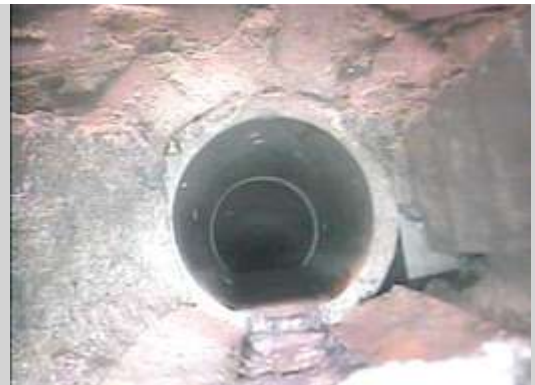
6 in. Circular Gravity Sewer

Pipe Material: **Clay**

Invert Depth: **7.62** (ft.) Flow Characteristics: **Slow**

Infiltration: **Evidence**

Pipe Seal Cond: **Broken**
